Warperup Creek Improvement Plant Feasibility Study 2022

SUPPLEMENT 3 - Waterway condition assessment framework

Prepared for North Stirlings Pallinup Natural Resources Inc

November 2022

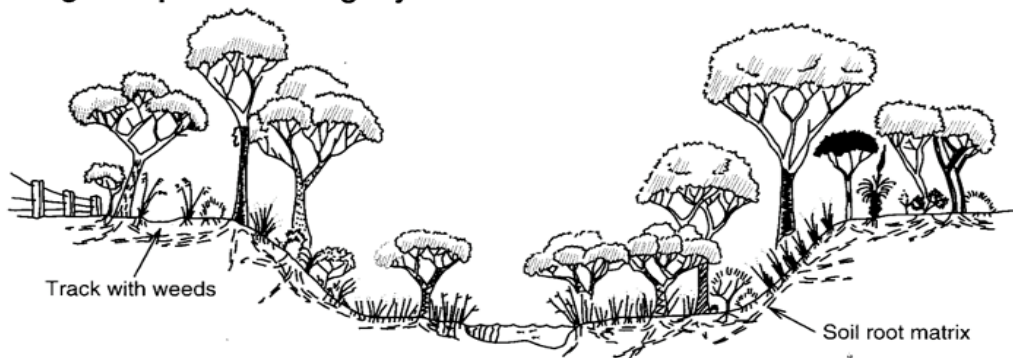
A grade: pristine to slightly disturbed

: Pictorial representation of the Pen-Scott four basic foreshore condition grades

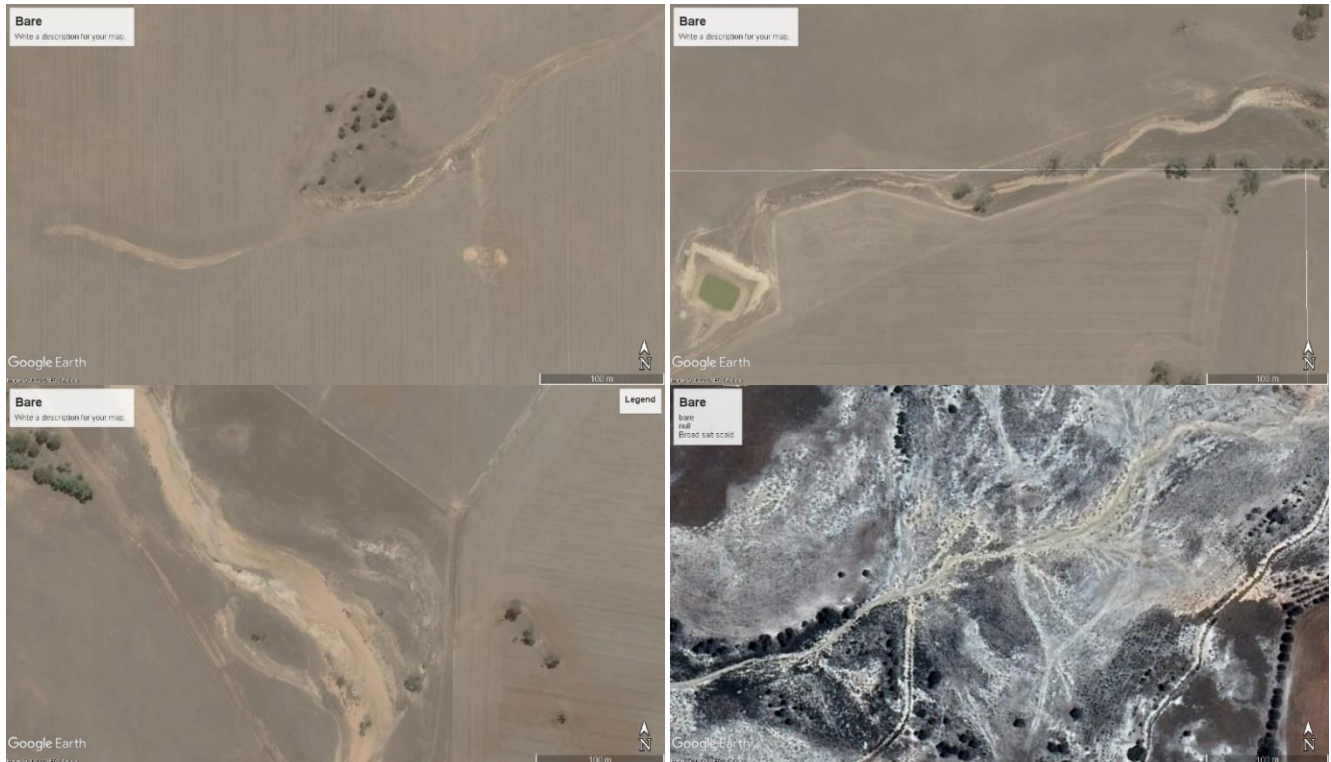
Bare of trees and shrubs

The majority of the stream section is bare of trees and shrubs. Width was not recorded.

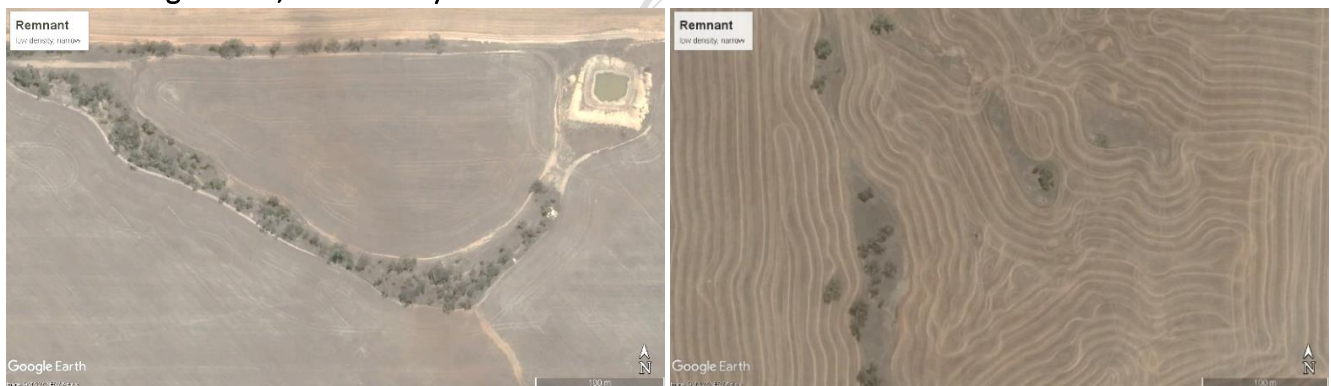
Remnant vegetation, low density, narrow width.

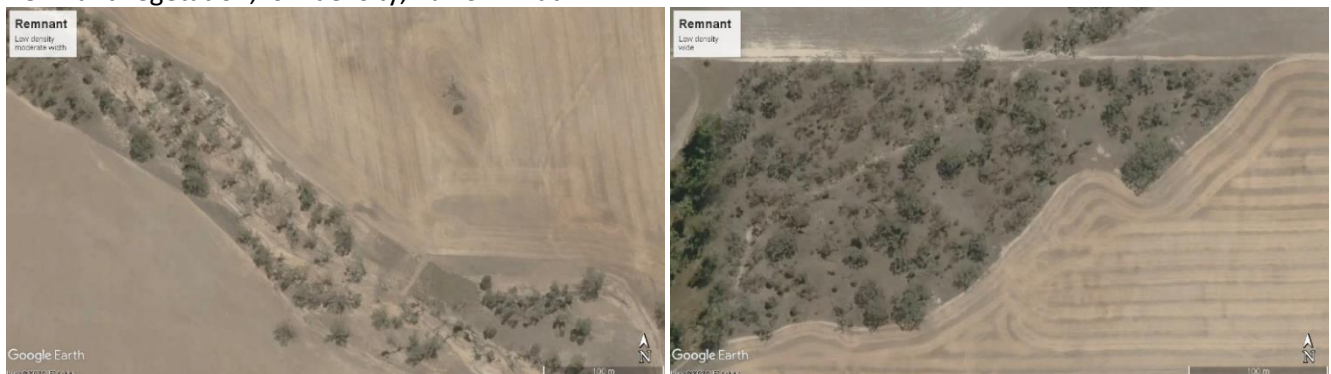
Remnant vegetation, low density, moderate width, and low density, wide.

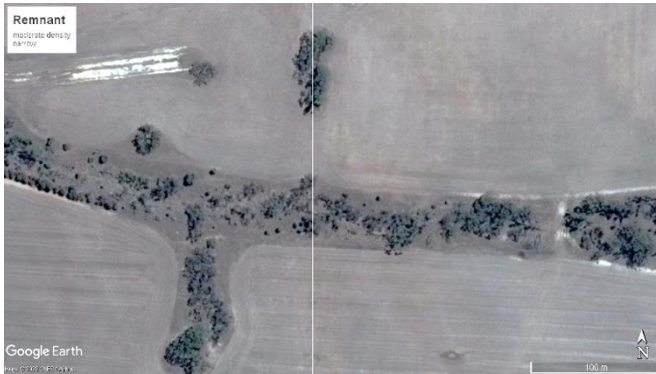
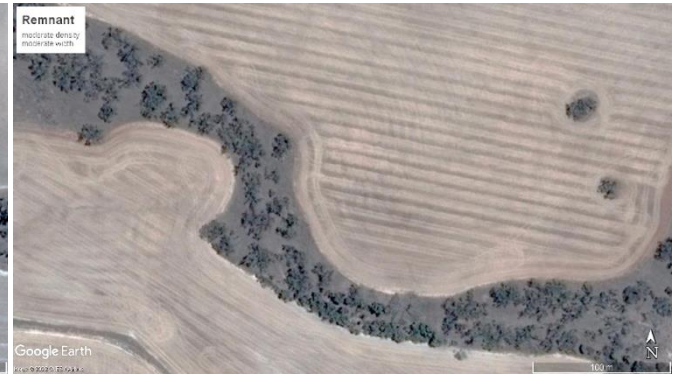
Remnant vegetation, moderate density

Remnant vegetation moderate density, narrow and

moderate density, moderate width

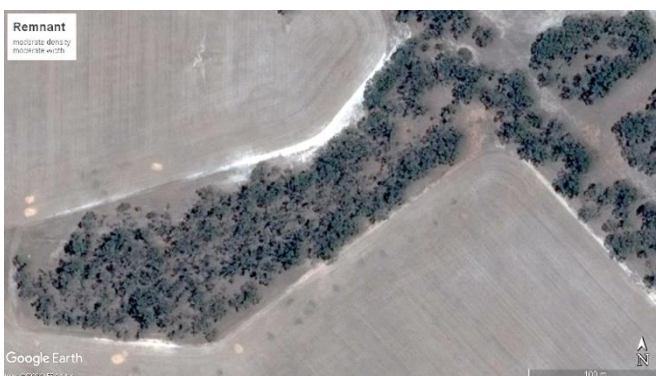
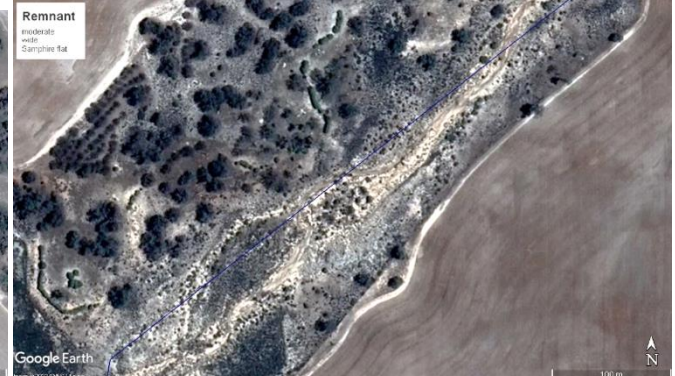
Remnant vegetation moderate density, moderate width and moderate density, wide. Note some revegetation apparent, and Samphire increasing density of cover.

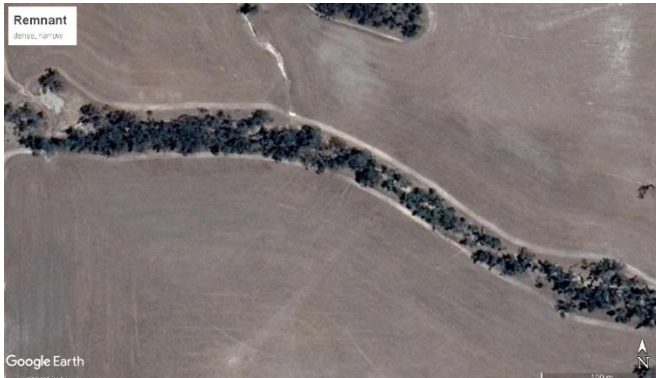
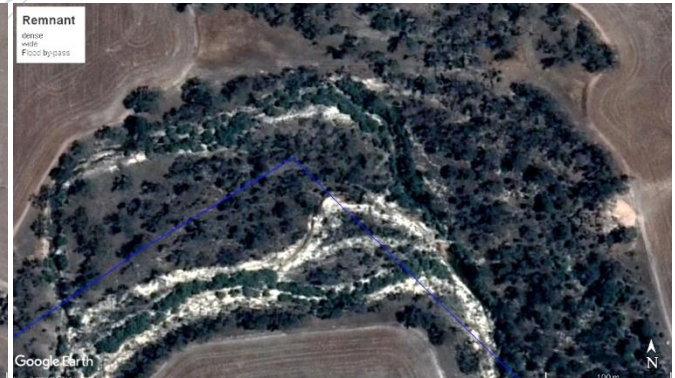
Remnant vegetation, high density

Remnant vegetation, high density, narrow and lines of Sheoak trees.

high density, wide. Note the flood bypass with

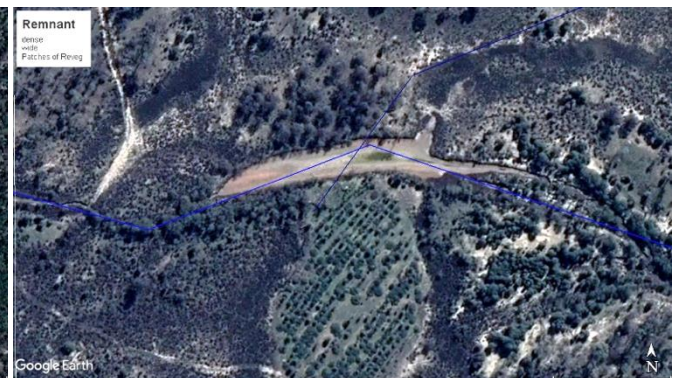
Remnant vegetation, high density, wide and

high density, wide with a patch of revegetation.

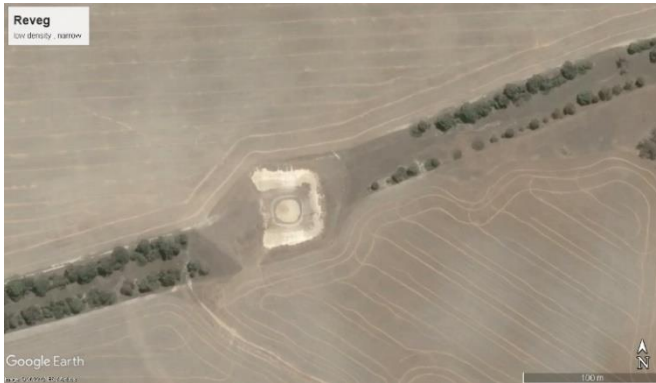
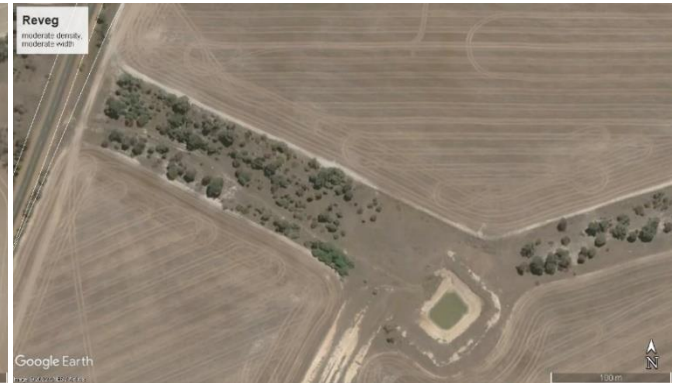
Revegetated

Revegetated, low density, narrow and

moderate density and moderate width.

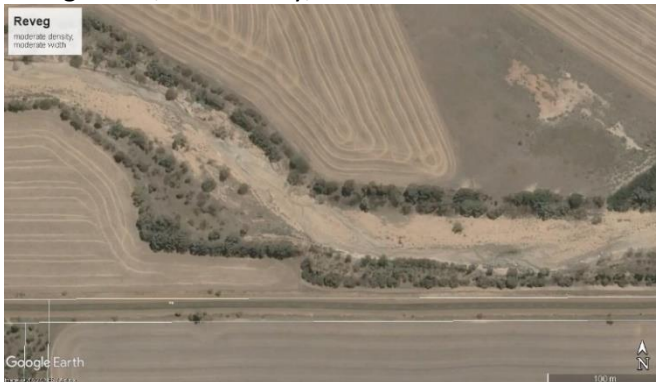
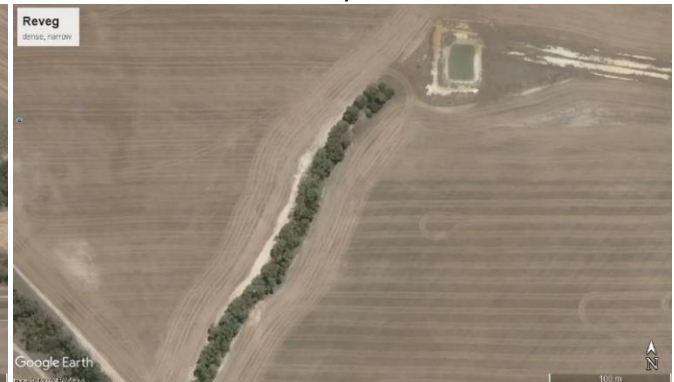
Revegetated, moderate density, moderate width and

dense, narrow

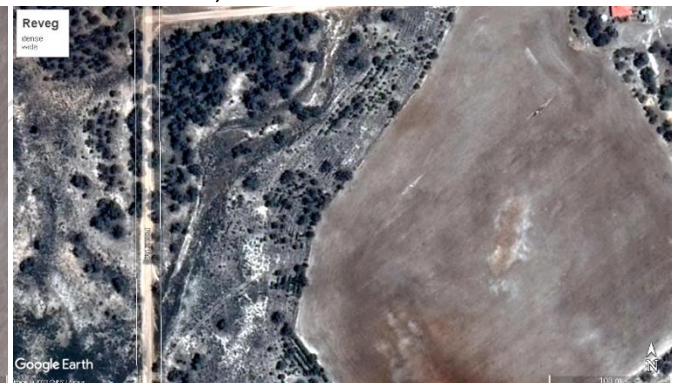
Revegetated, dense, narrow and vegetation.

dense, wide with patches of remnant
