Warperup Creek Water Condition Monitoring

Supplement 4 - Results for 2020 to 2022

Prepared for North Stirlings Pallinup Natural Resources Inc.

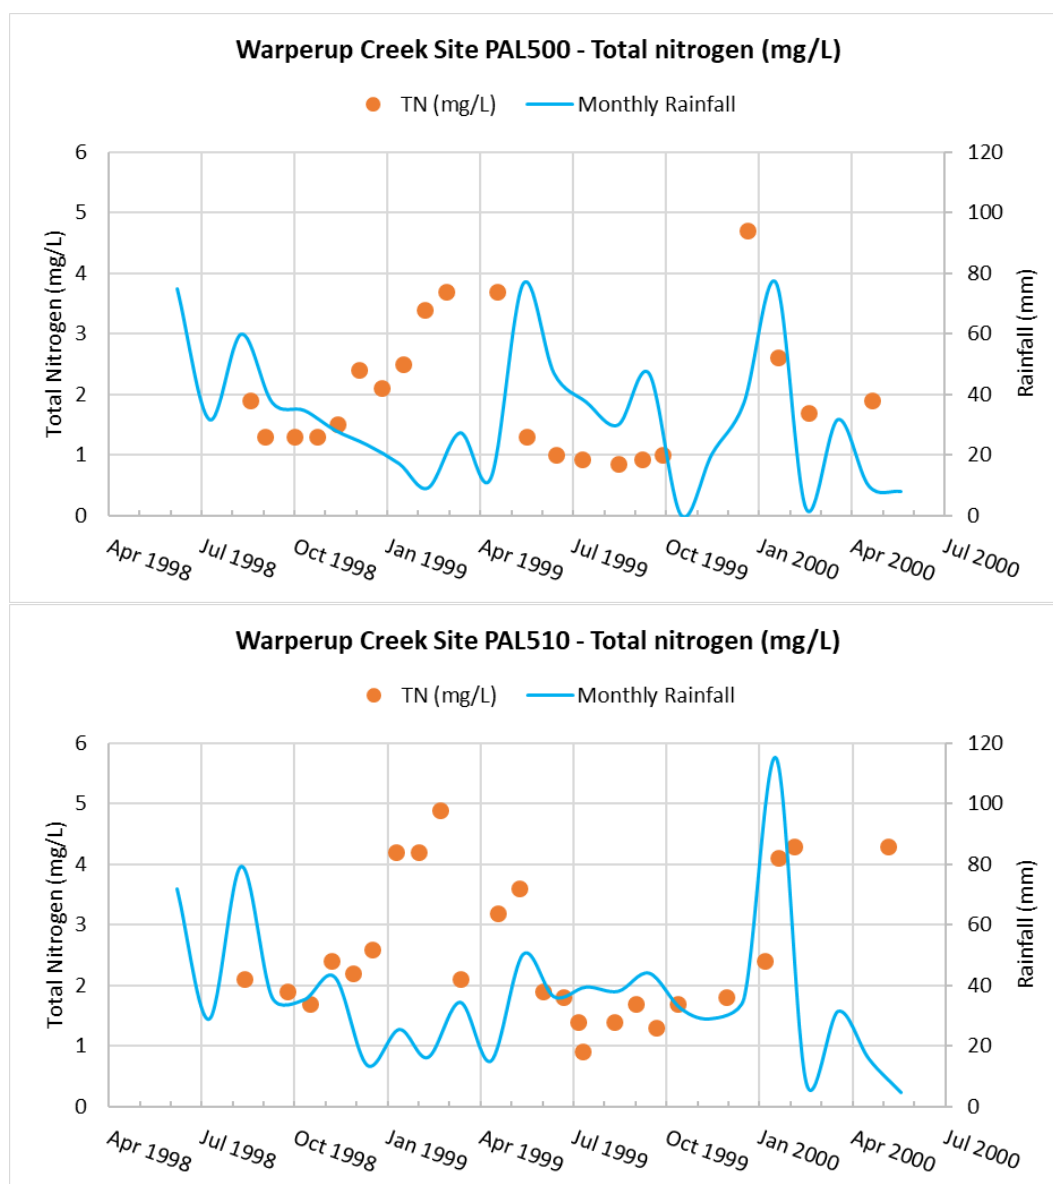
Figure 9: Total nitrogen values during the 1998 to 2000 sampling program for two sites at the lower and top ends of Warperup Creek. Monthly rainfall over the period is shown as a blue line.

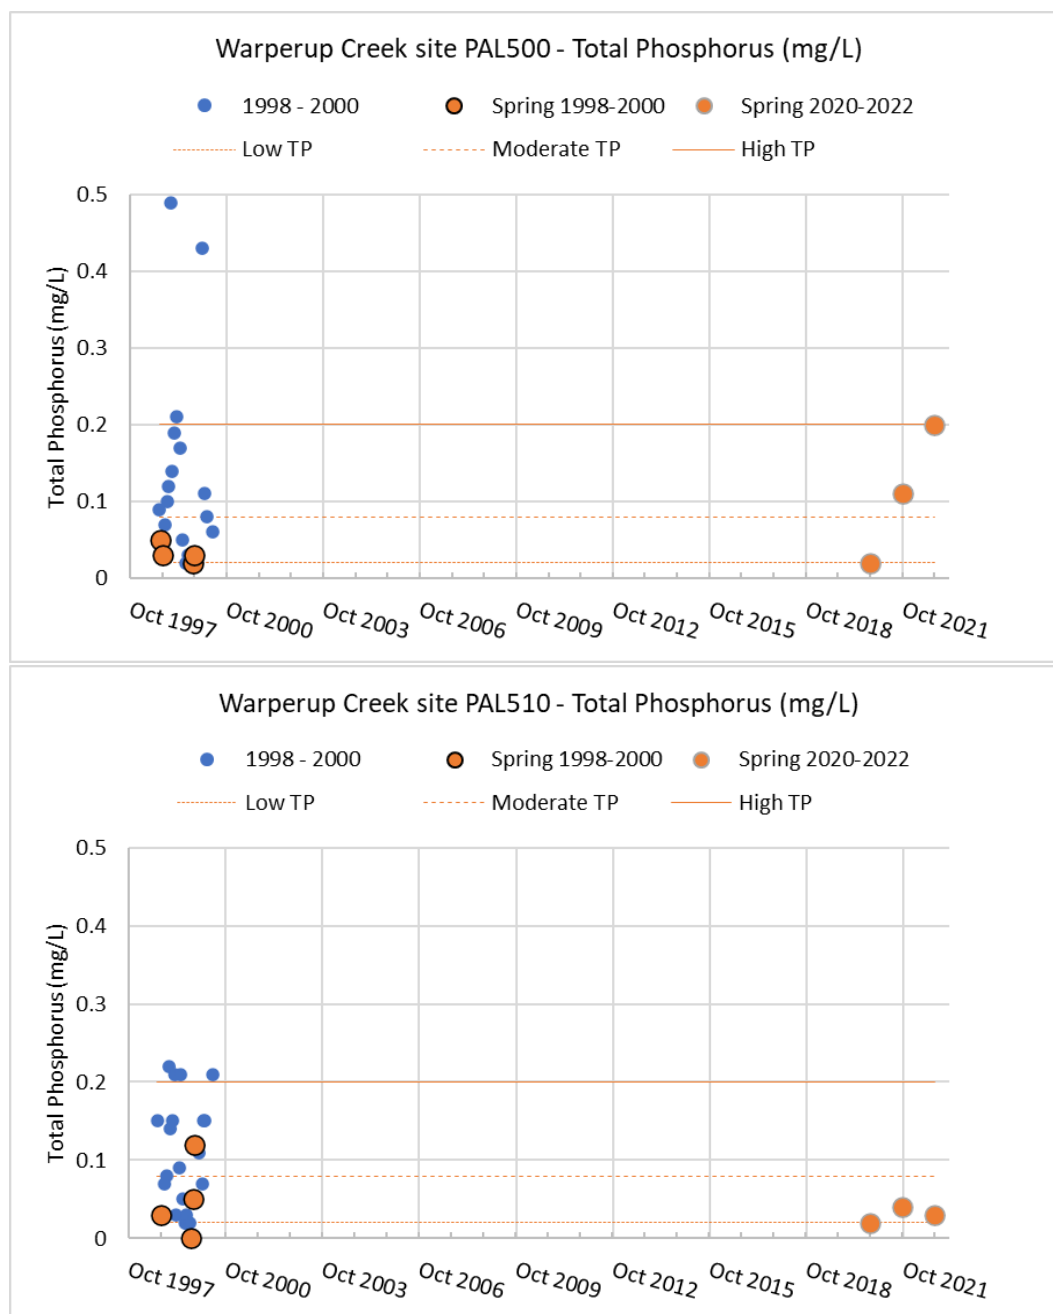
Figure 14: Total Phosphorus comparisons between 1998-2000 and 2020-2022 at sites PAL500 and PAL510.

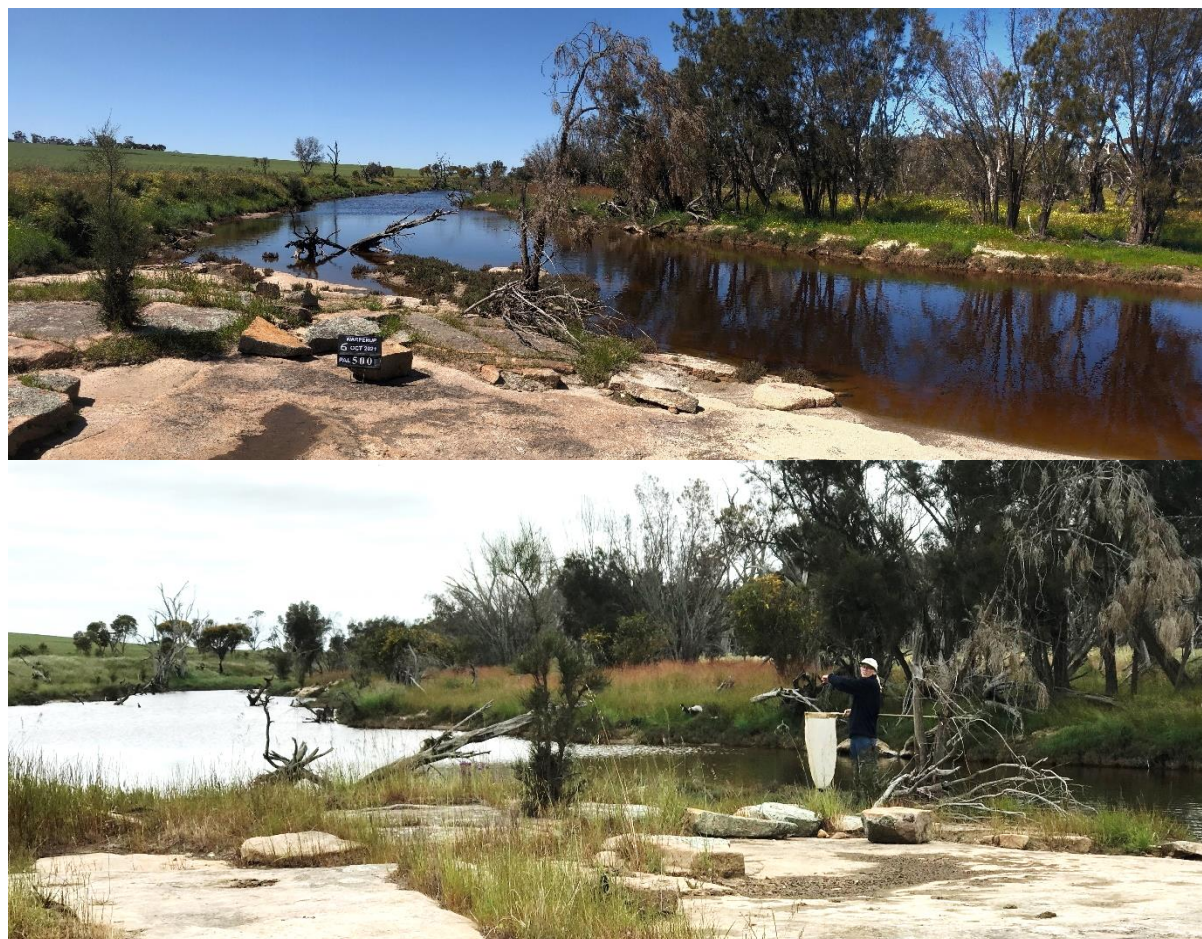
This reach is at the lower end of Warperup Creek on the south side of Maileerup Road and runs parallel to it. In the late 1990s the accuracy of GPS devices was poor and location coordinates could vary by up to several hundred meters at different times. This site was sampled in the days of the Waters and Rivers Commission (1998-2000), most probably at the Maileerup Road crossing near the top end of the reference reach rather than at the current site at the downstream end.

Figure 24: Sampling site PAL500, lower Warperup Creek on 6 October 2021 and 13 October 2020.

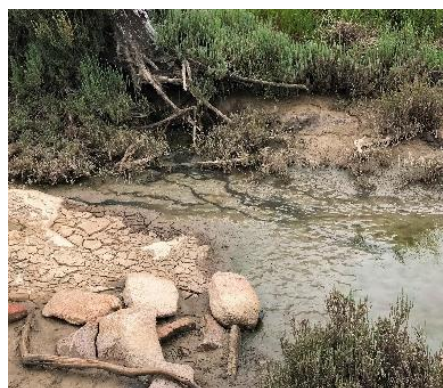
This shallow pool had moderate to high Total Nitrogen values and high dissolved nitrates and nitrites in 2020. Total Phosphate levels in 2022 were high and the TN:TP ratio was low (13) indicating that potential eutrophication was controlled by Nitrogen inputs. Figure 25 shows water seeping out from under a sandy bank at the sampling site. The high algal growth within the seepage indicates higher nutrient levels.

Figure 25: Water seeping from under a sandy bank at PAL500 in October 2022. The high algal growth indicating high nutrient levels.

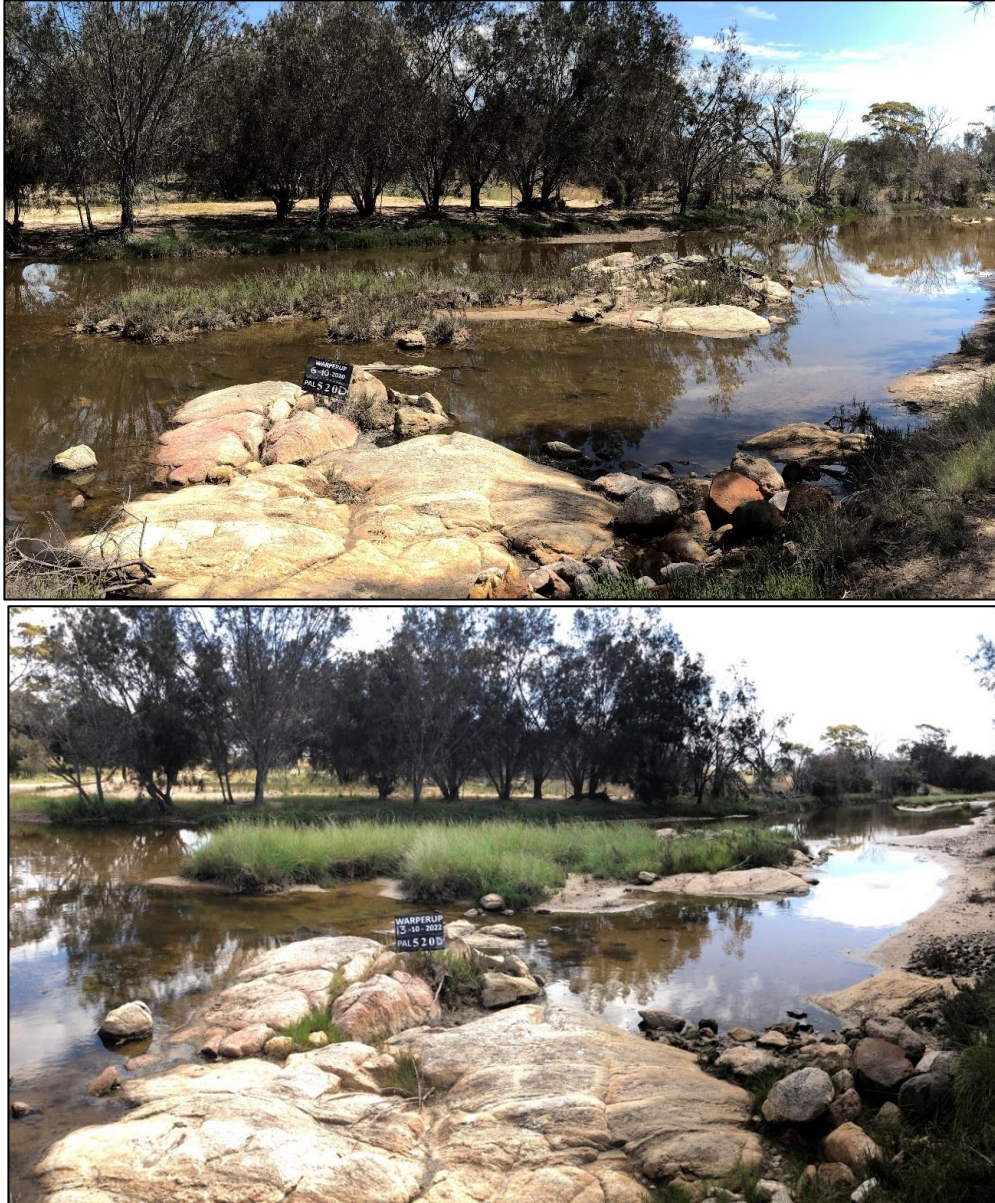
This site had the lowest aquatic diversity, and the most abundant taxa were midge, mosquito and brine fly larvae. Seed shrimps were present in abundance in 2020 and 2022 but were noticeably absent in 2021. In 2022, the TN values were very high, but the TP values were low. There was a benthic algal mat present in sections of the stream.

Figure 26: Sampling site PAL520, Mailerup / Long Creek in October 2020 above and 2022 below.

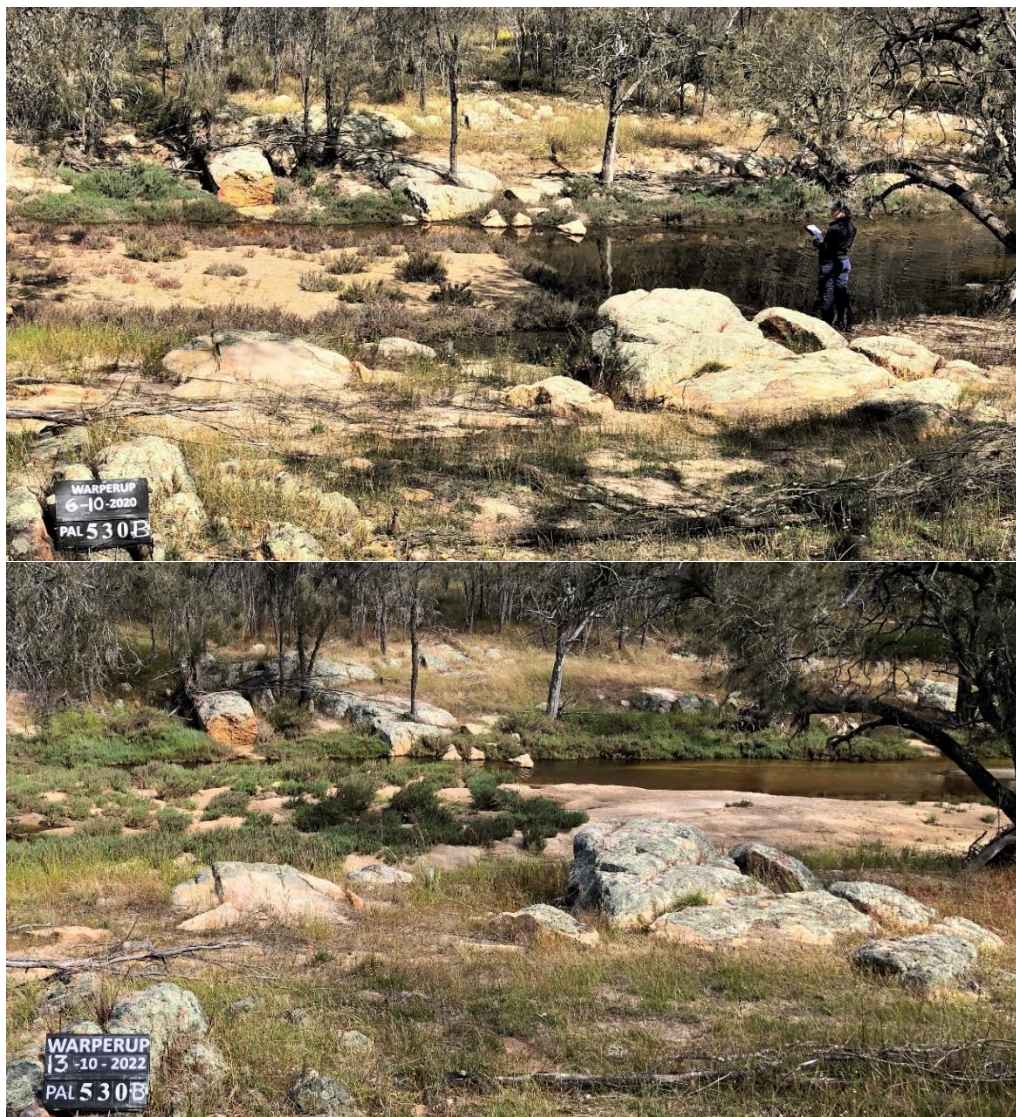
The water level at this site is controlled by a rocky bar a short distance downstream. The upstream reach is dominated by bedrock. Despite the high rainfall in June and July 2021 compared to 2020, the water depth was reduced in 2021 (see Figure 27 and Figure 28) due to an influx of sand. The Bureau of Meteorology daily weather observations for Ongerup show that in 2020 the area received 10.8mm rain in the four days preceding the 2020 sampling and in 2021 only received 3.4mm of rain. It should be noted that variations in water level can give the casual observer a misleading assessment of sediment quantities and movement.

Figure 27: PAL530B, Coromup Creek in October 2020 and 2022 showing increase in sediment in the waterway

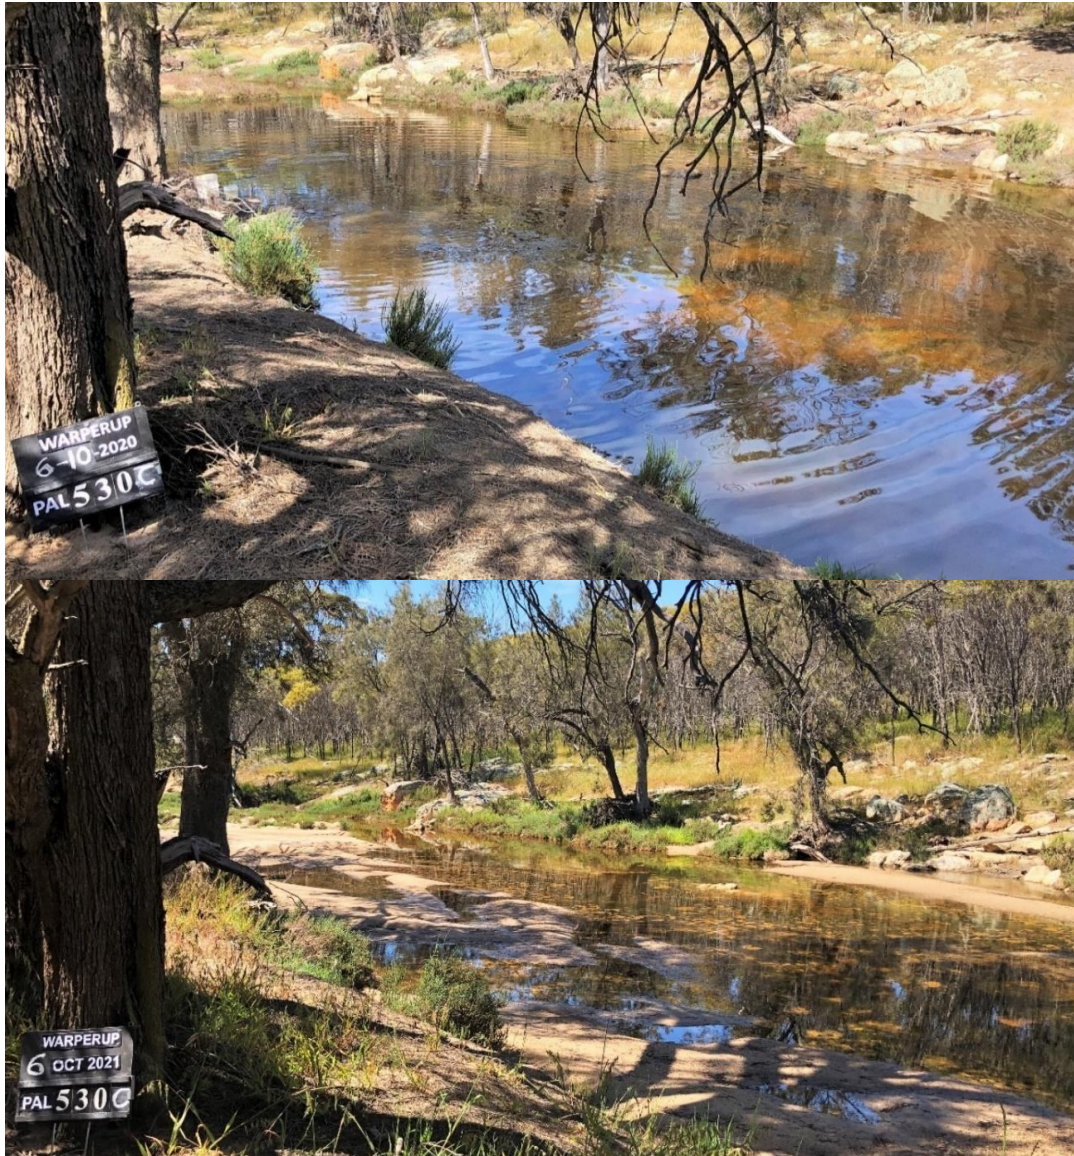
Figure 28: Sampling site PAL530C, Coromup Creek in October 2020 and 2021 showing increase in sediment in the waterway

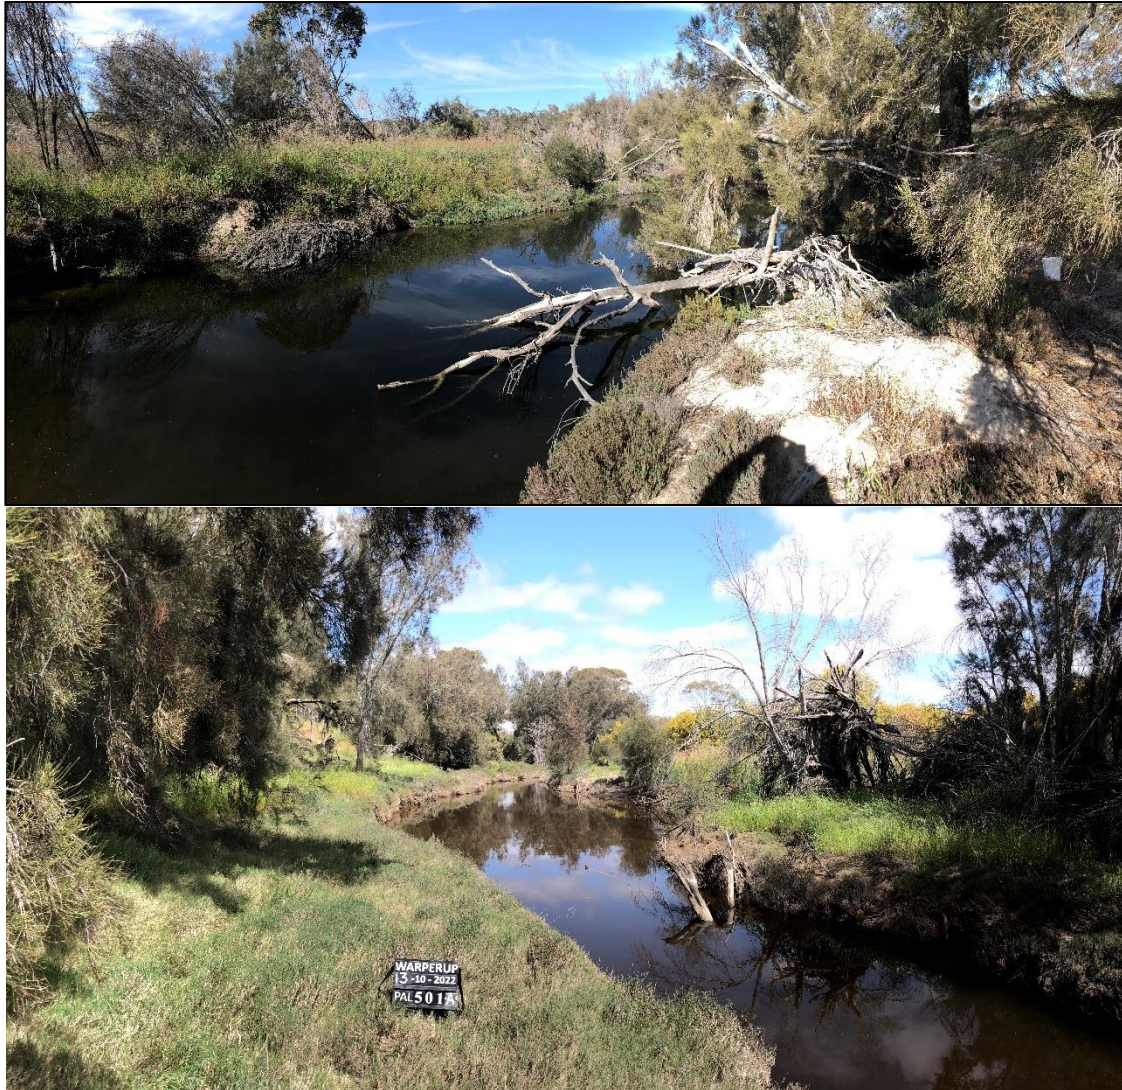
A water monitoring site was established at the Chester Pass Road Crossing in 1998-2000 by the then Water and Rivers Commission. For the 2020 monitoring program, the floodway adjacent to and extending upstream from the Golf Club house was chosen as the reference reach. The sampling location in 2020 and 2021 was downstream of the Club House but it was felt that the location was too difficult to access due to a very steep bank and the monitoring site was relocated to a site upstream in 2022. See Figure 30 below.

Figure 30: Sampling site PAL501, Warperup Creek in October 2020 (above) and the new location PAL500A, upstream from the original site (below).

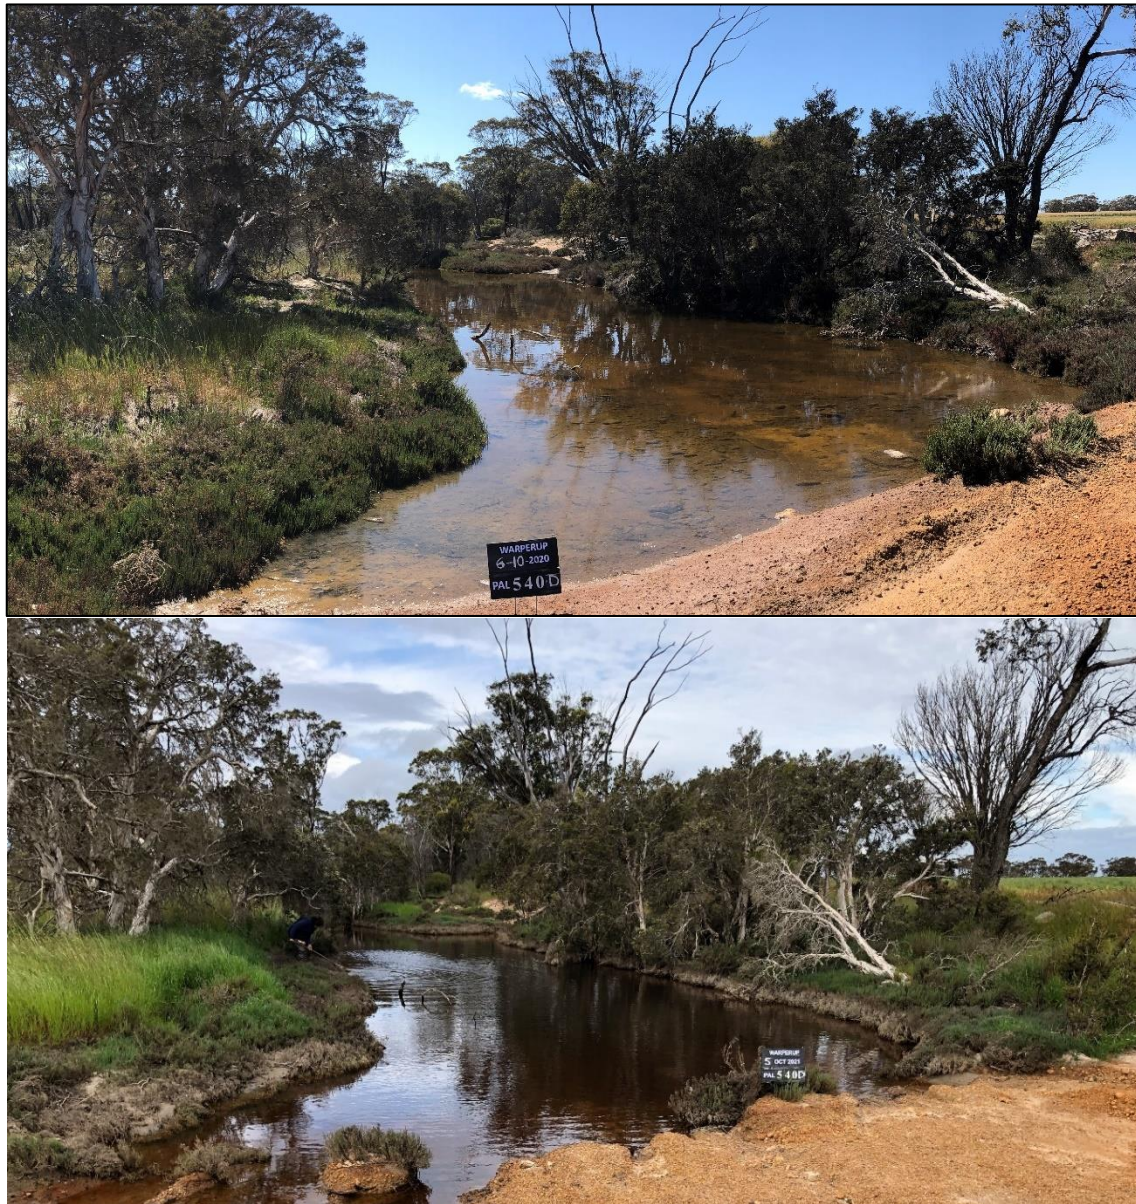
Aquatic diversity was slightly higher than most of the other monitoring sites with an abundance of *Coxiella* snails, copepods, scuds and midge larvae.

Figure 31: Site PAL540 on Peedillup Creek in October 2020 and 2021

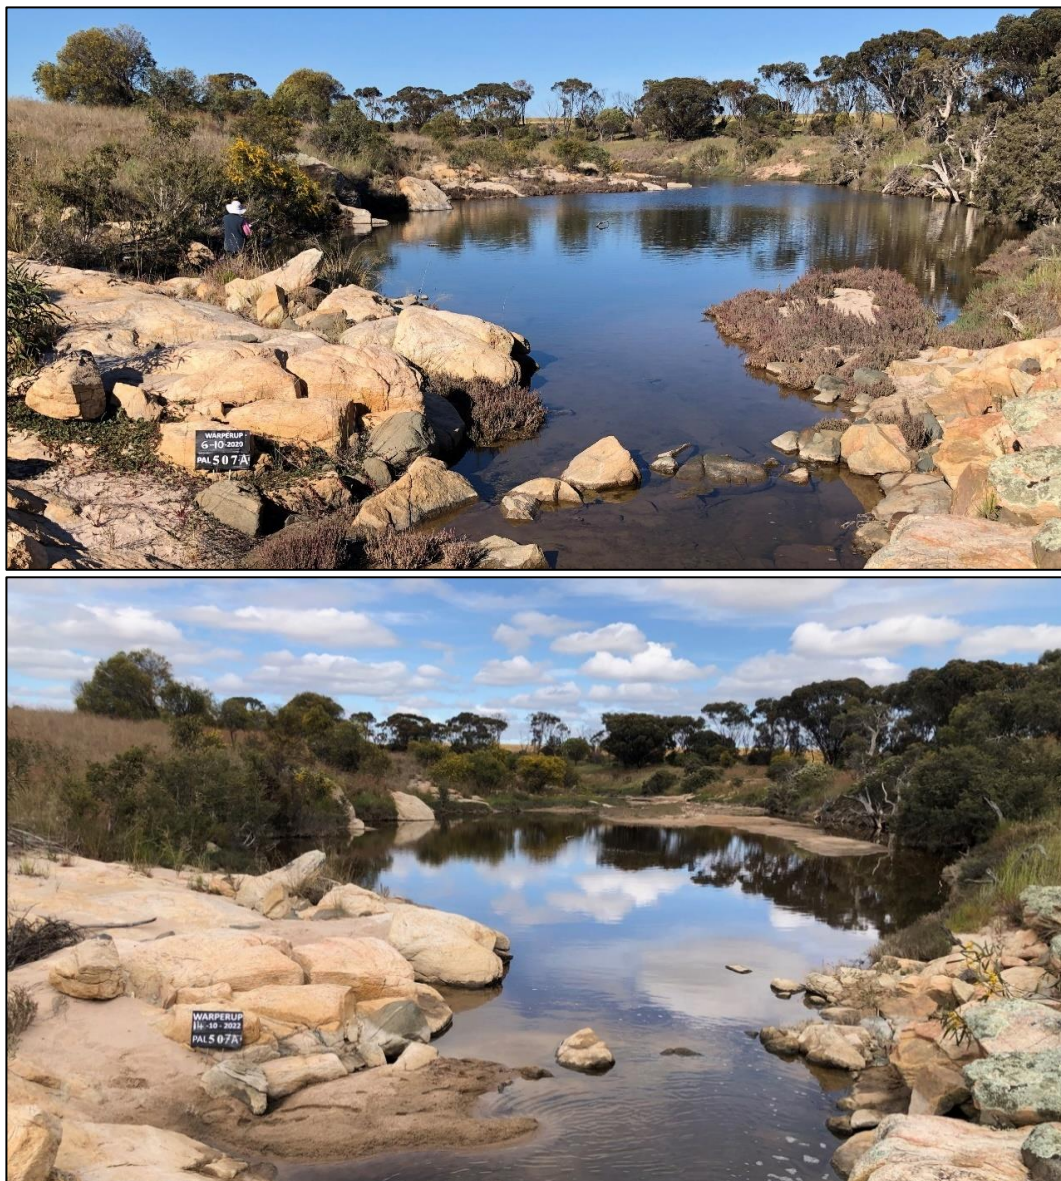
Sediment on near right bank (See Figure 32) had been stripped away during the previous 12 months and more sediment had been deposited at the downstream end of the pool. The water level in the pool in 2021 was higher than in 2020 which may be due to the sediment bar at the downstream end of the pool constraining the flow. The aquatic environment included an abundance of seed shrimps, scuds and midge larvae.

Figure 32: Site PAL507 on Warperup Creek in October 2020 and October 2022.

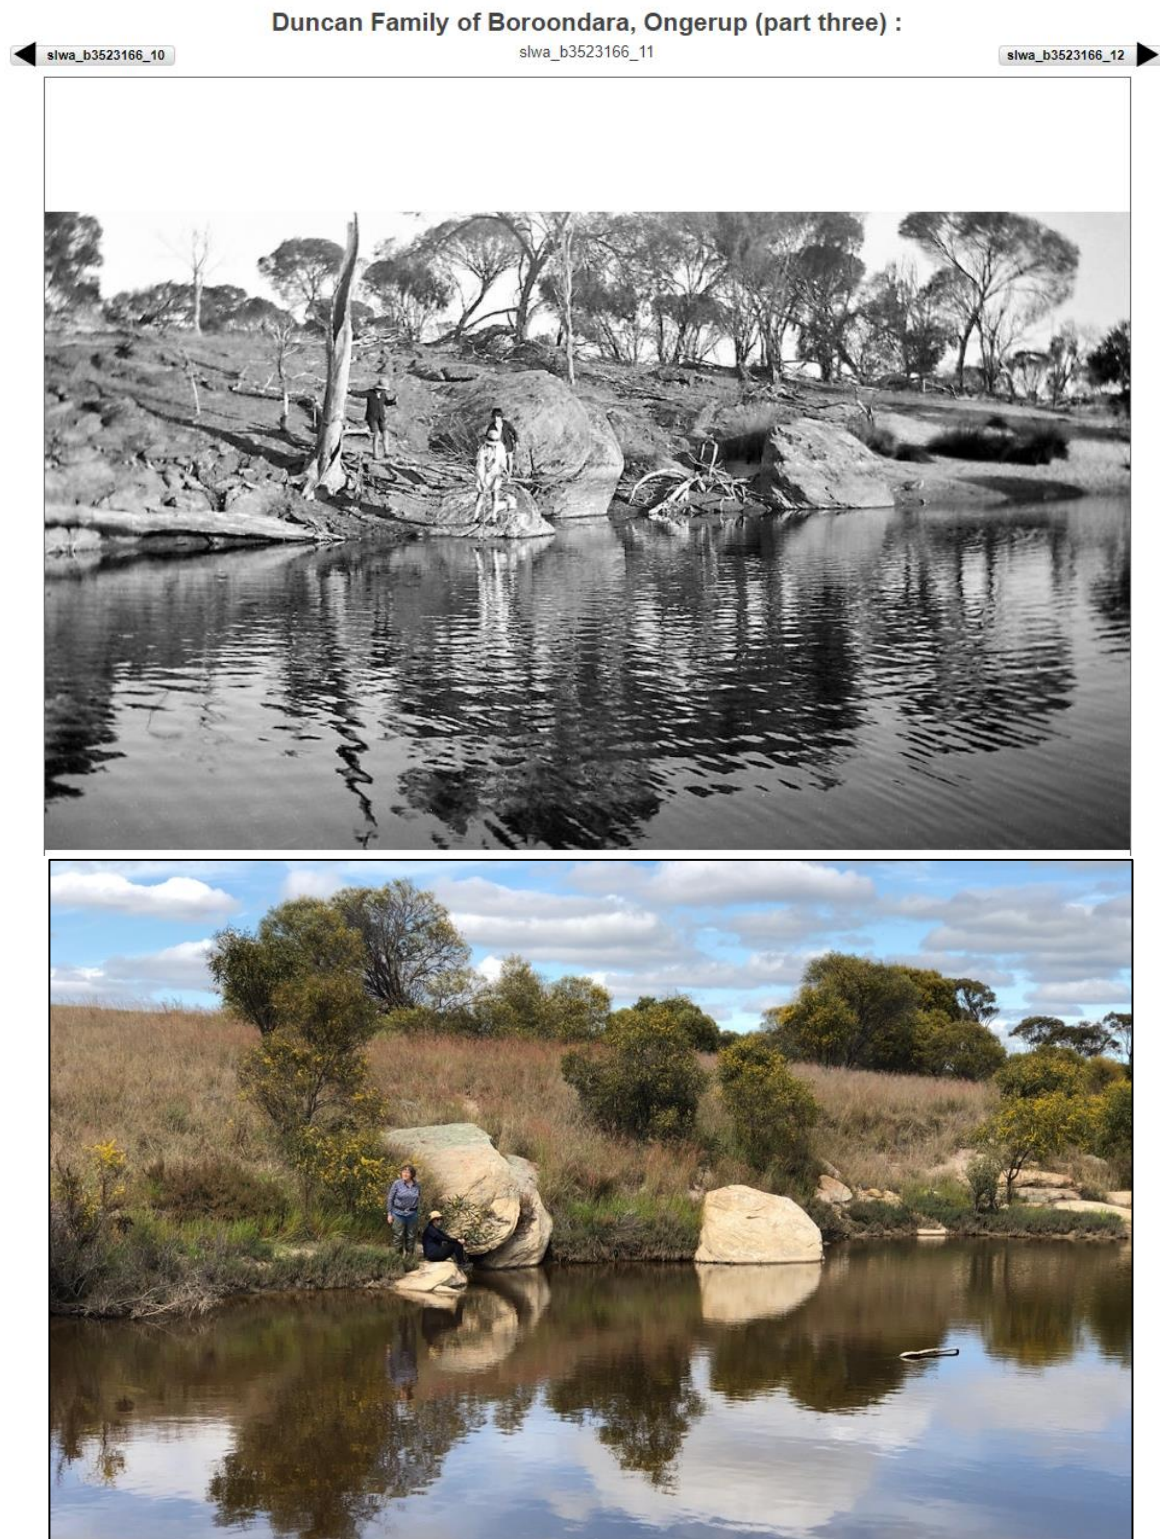
Figure 33: Comparison between a photo taken in 1930s⁷ and one from the same location in 2022.

Figure 33: The different features shown at the site after an interval of 80 to 90 years tell a story. In the 1930s the banks were largely denuded of vegetation which suggests high stock use of the area. The exposed soils would have been primed for flood erosion. The presence of a clump of sedges in the 1930s indicates these were present in the riparian zone but by 2020 ground cover has become dominated by veldt grass which nevertheless may serve a similar stabilising function. Large trees had been present close to the water but by the 1930s had died and in 2022 wattles have replaced Eucalypts although these are still present in patches.

The increase in cropping activity in the catchment over time can be said to have had a positive effect on floodway stability since the reduction in stock grazing pressure allow vegetation to recolonise the floodway, even if is largely by weed species. It is uncertain how extensive the earlier highly degraded conditions were throughout the catchment, but in one sense the location shown appears to have 'improved' in an ecological sense.

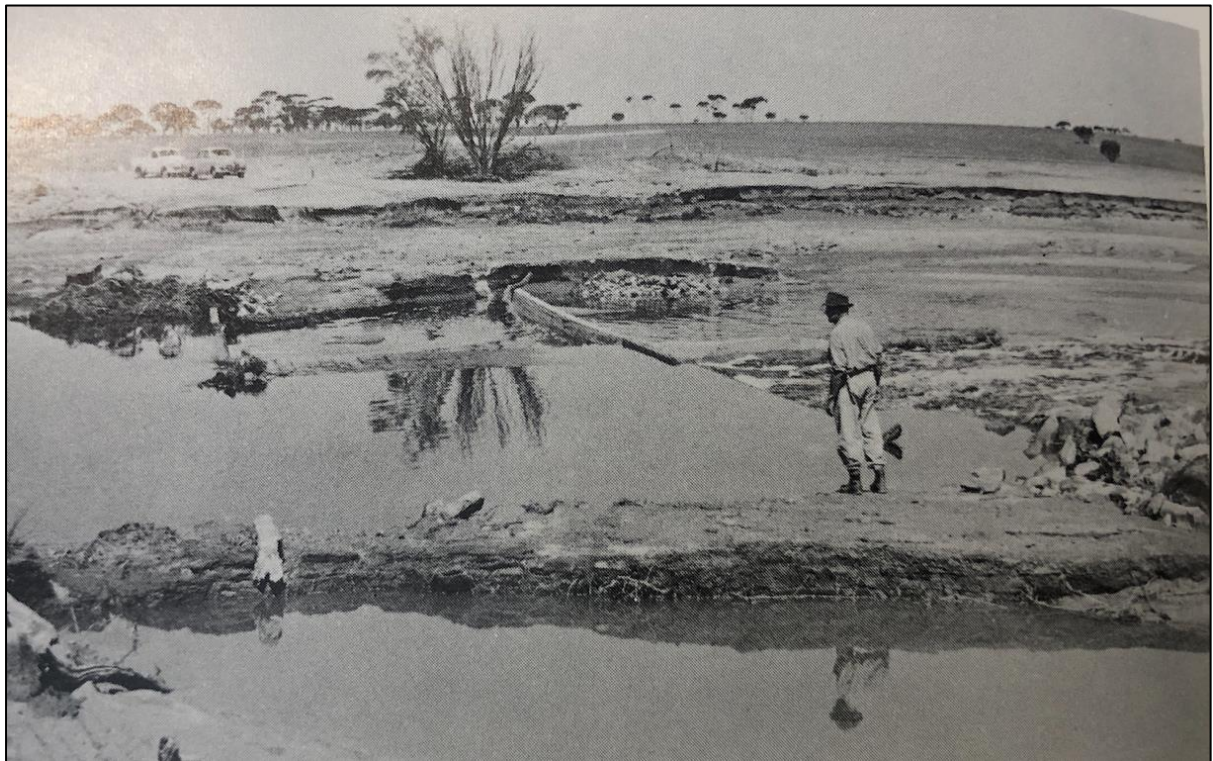
The image below (Figure 34) of a crossing on Warperup Creek also suggests that stream banks had been quite denuded.

Figure 34: A flood damaged crossing on Warperup Creek or Pallinup River 1955. (Source unknown)

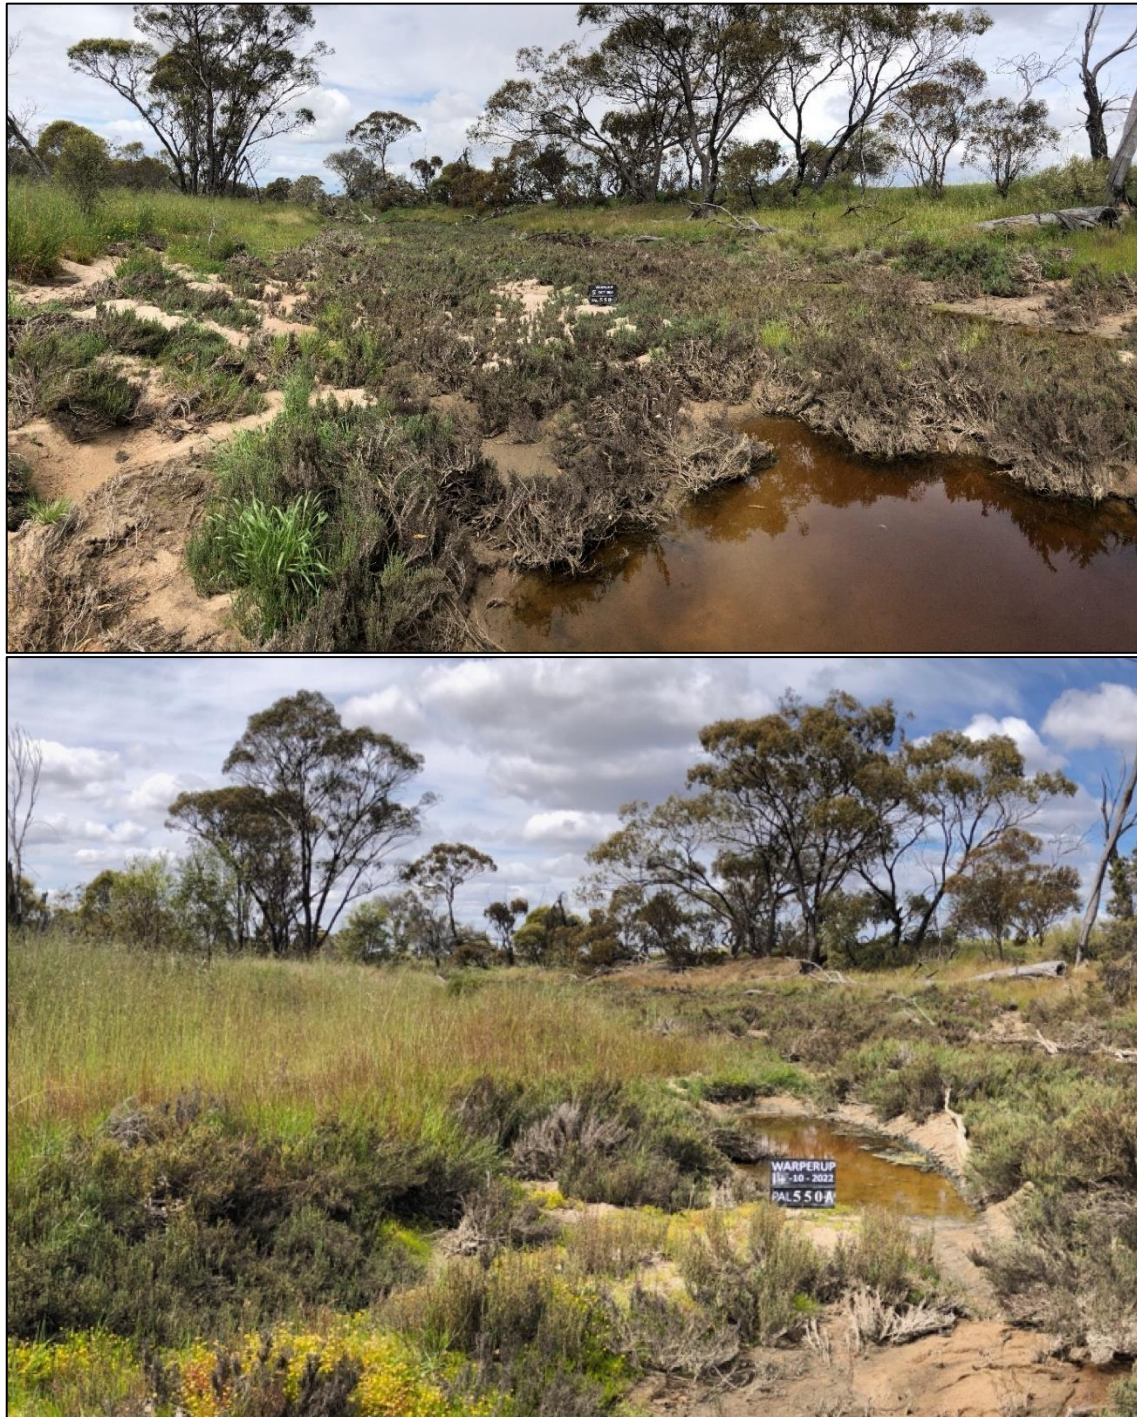
Figure 35: Conditions at this site had remained much the same from 2020 to 2022

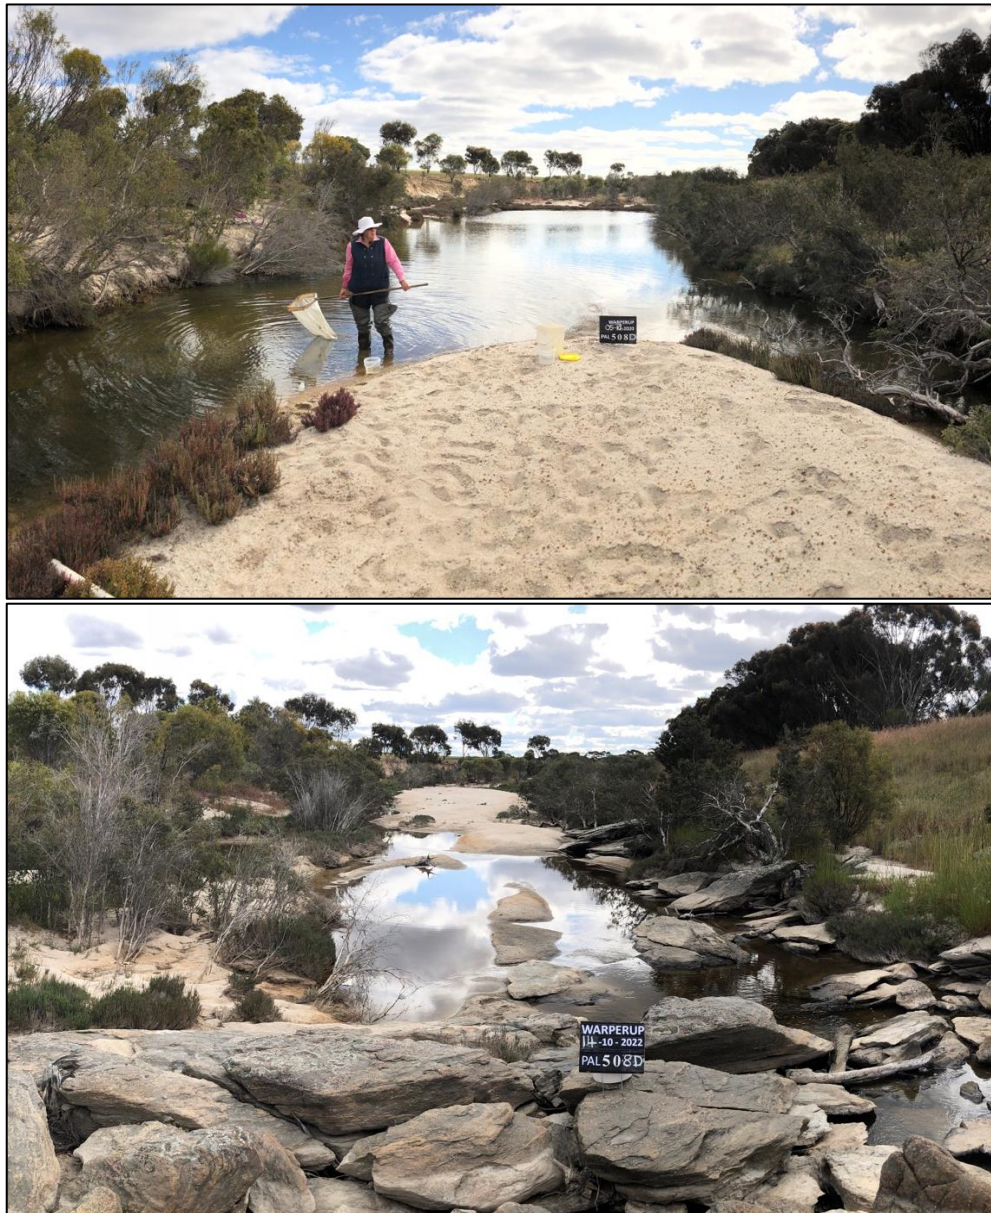
Figure 36: Site PAL508 on Warperup Creek downstream of Ongerup Creek in October 2020 and October 2021.

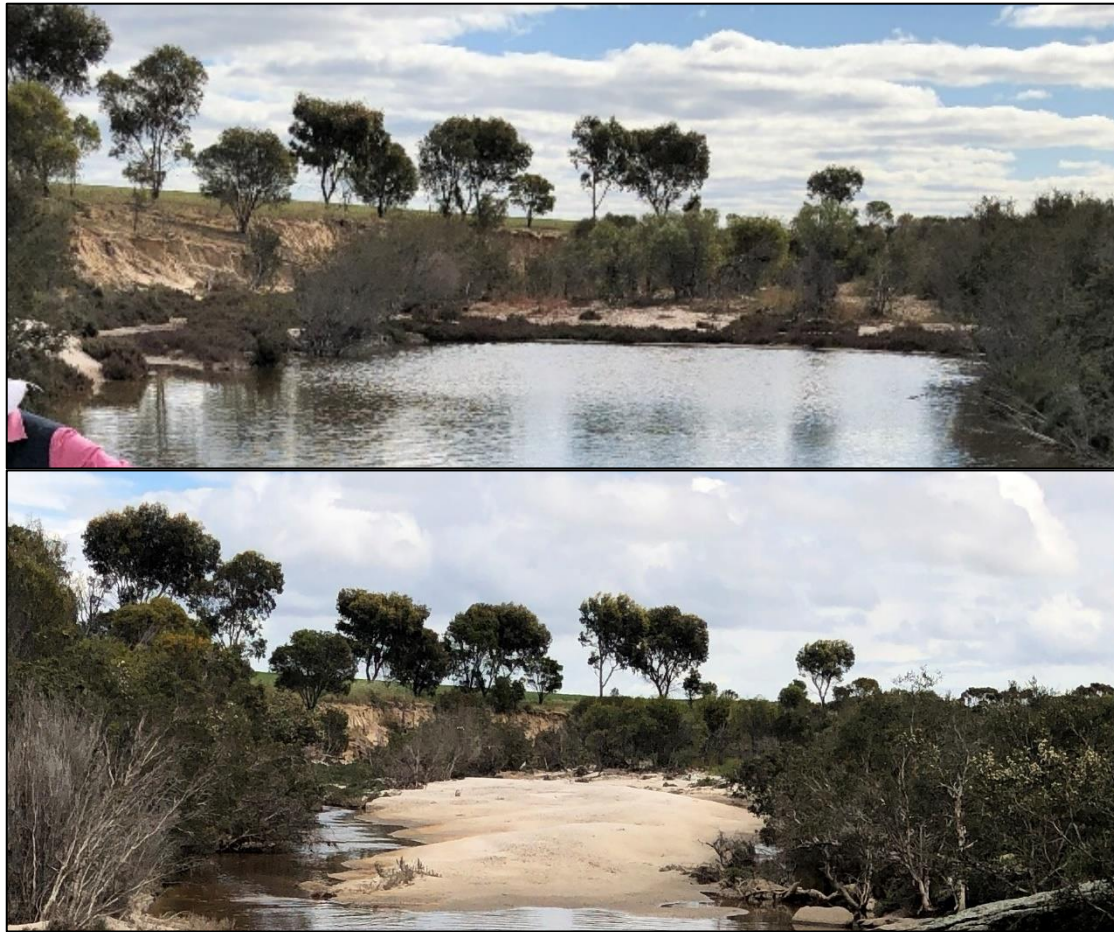
Figure 37: Zoomed in to the end of the pool at Site PAL508 on Warperup Creek, 2020 and 2021. Although the photo in 2021 was from a slightly different angle, the extent of sediment deposition can be seen.

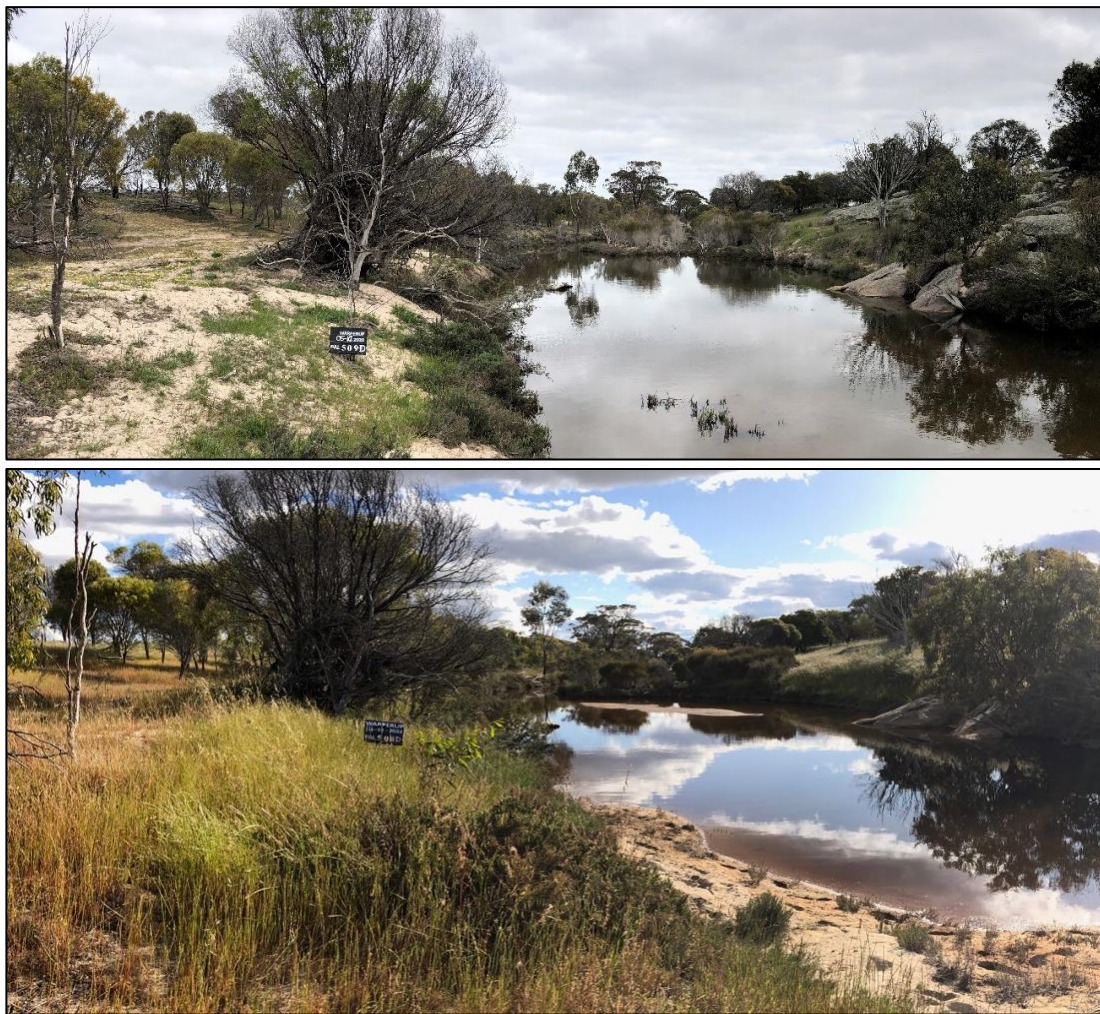
Figure 38: Site PAL509 on Warperup Creek downstream of Jaekel tributary in October 2020 and October 2022.

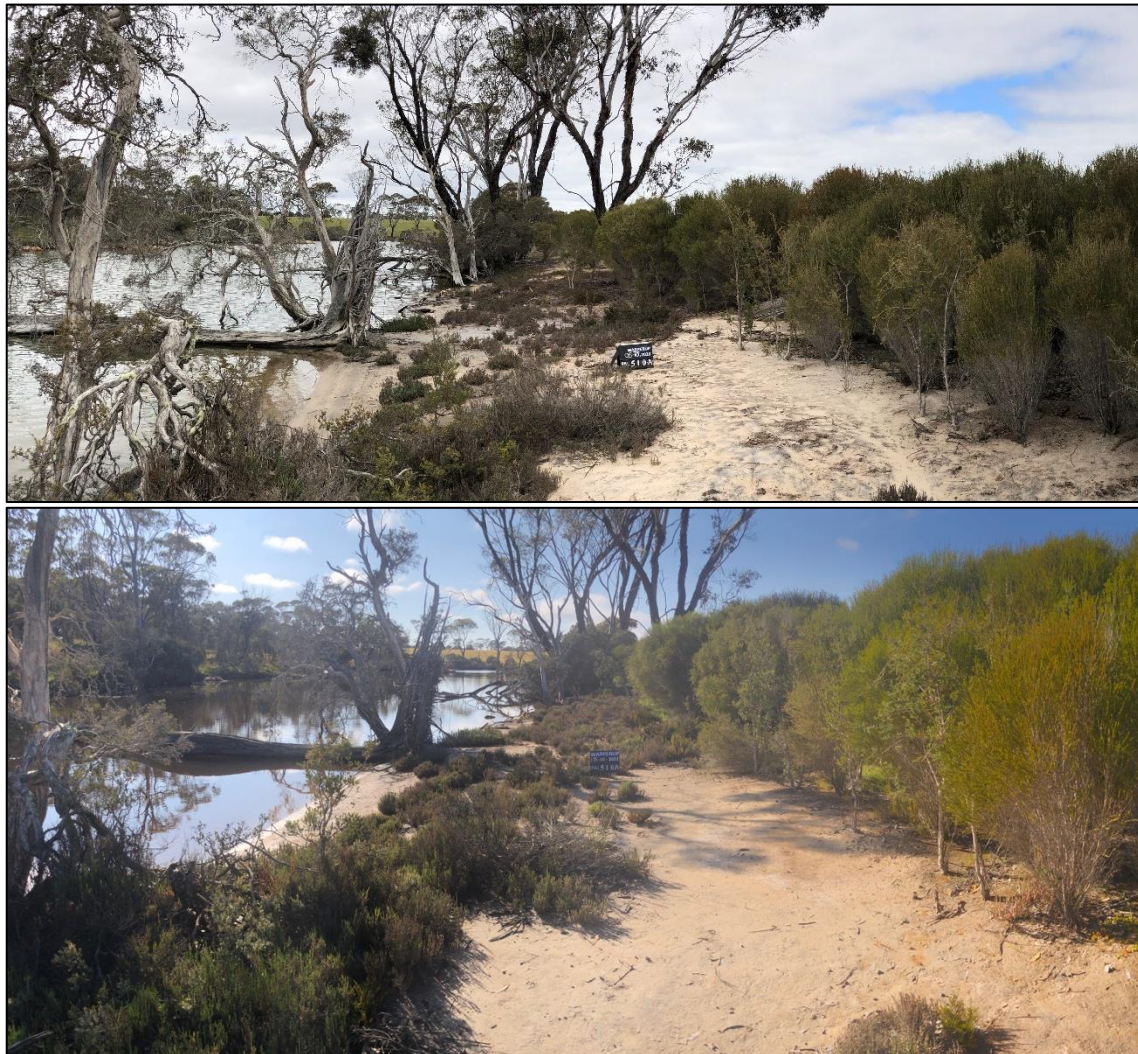
The aquatic environment was dominated by an abundance and diversity of seed shrimp, copepods, and scuds with midge larvae also abundant. The Goby was notably absent.

Figure 39: The upper most site on Warperup creek, Photo point PAL510 in October 2020 and October 2022.
